SIGIR INSPECTIONS

Project Assessments: Findings at a Glance

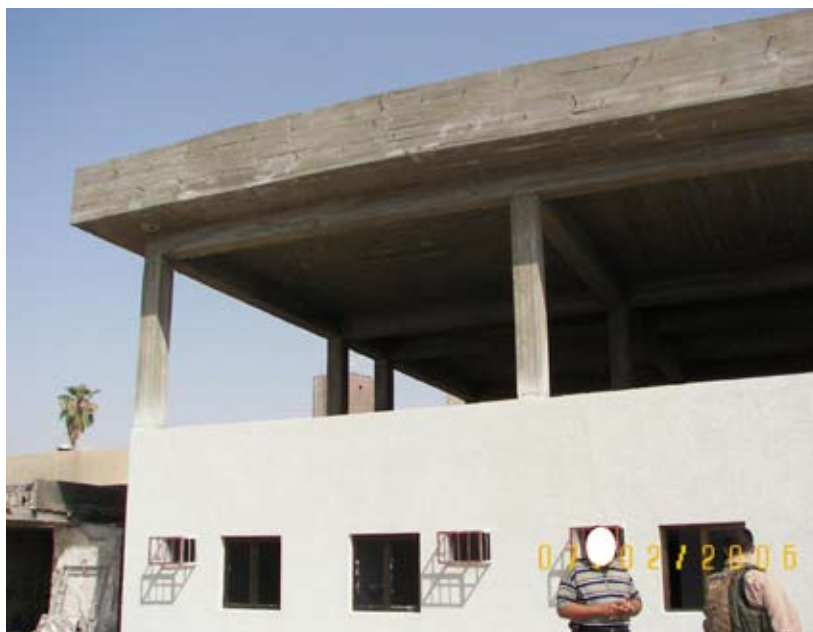
Site Photo 3. First-floor columns and beams supporting roof.

the ground floor and only a shell for the first floor (structural concrete frame, including the roof, Site Photo 3). Further, the telephone and oxygen piping systems were removed from the scope. In addition, the central HVAC system was replaced by individual room HVAC units.

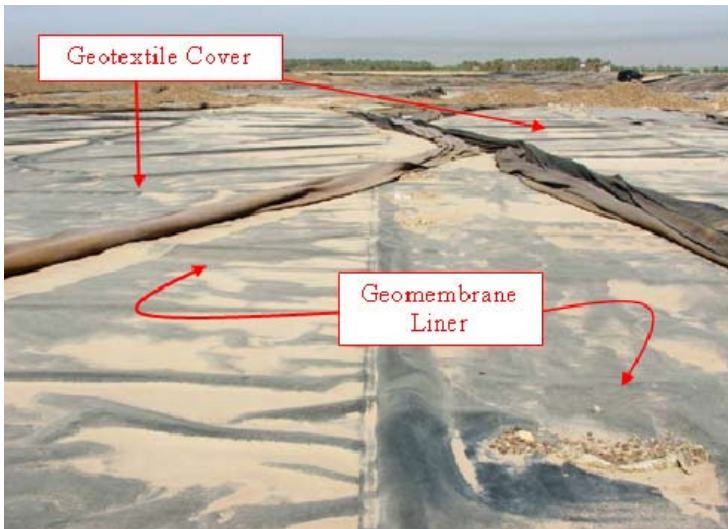
Site Photo 4. Exposed geomembrane liner.

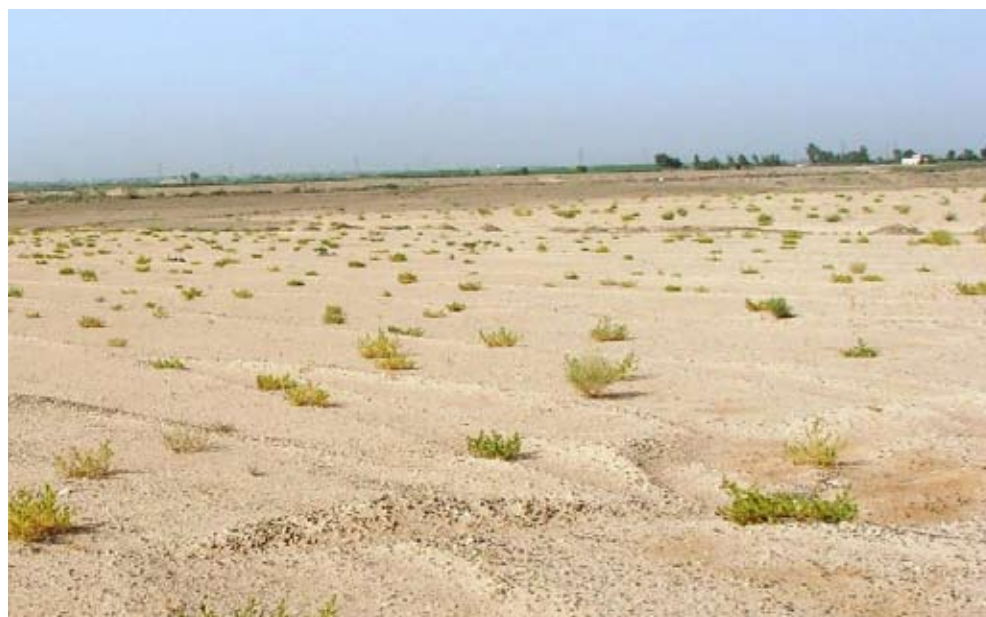
As designed, the leachate generated within the landfill, when operational, will percolate through the sand-gravel drainage layer to the liner. The landfill floor and overlaying liner is sloped so that the leachate will drain into a collection trench. SIGIR also inspected the four leachate collection pump stations—the

Site Photo 5. Surface of the drainage layer.

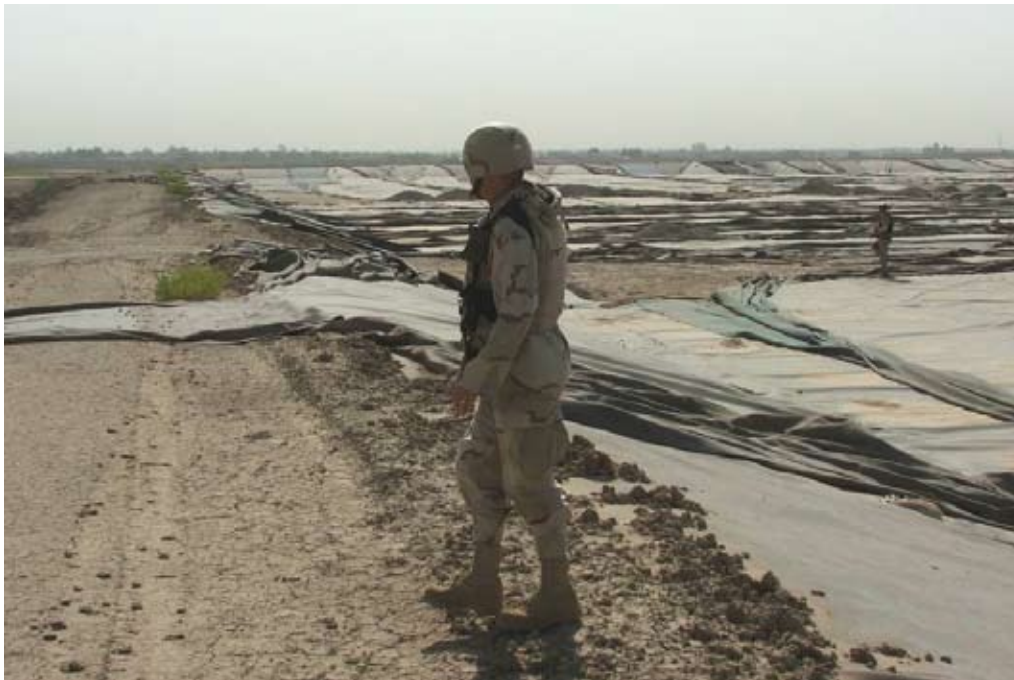
The perimeter berm around the MSW landfill comprised an embankment of various heights constructed with a horizontal to vertical slope. SIGIR observed the berm in place along the perimeter of the MSW landfill. In the unfinished areas of the landfill, the liner along the inside of the berm will require remedial work to ensure that it is placed and anchored properly (Site Photo 6).

Site Photo 6. Section of the perimeter berm requiring remedial work to anchor the liner.

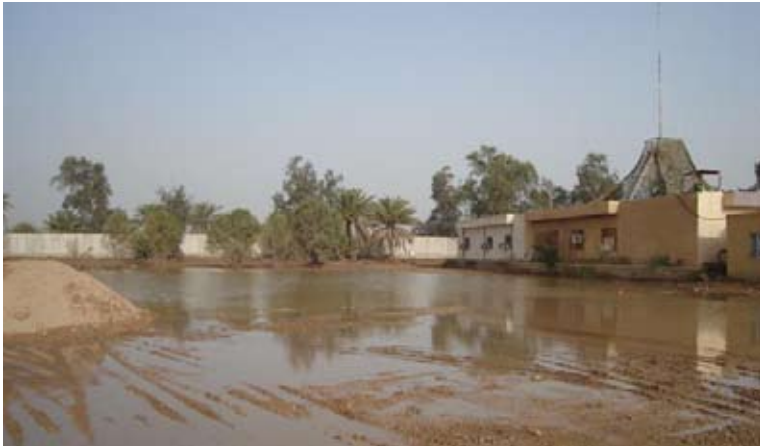
Site Photo 7. Standing wastewater pooled on academy grounds. (Photo courtesy of ECCI)

The design and installation of the septic tanks system were inadequate to support the population of the academy. There was no requirement for a drain field in the original design, which depended on pump trucks to remove any excess effluent. Insufficient soil drainage, limited pump truck capacity, and a daily water volume input that exceeded septic tank capacity contributed to the problem, resulting in substantial overflow of wastewater from the septic system and pooled on academy grounds (Site Photo 7).

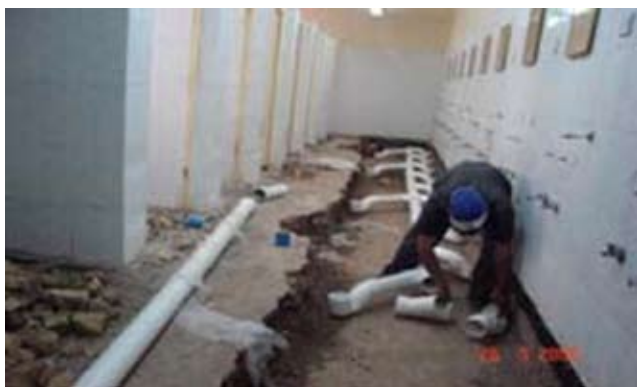
Dormitories accepted by the government on August 31, 2005, and December 9, 2005, required extensive rework of the bathrooms to correct defective plumbing construction that should have been detected, monitored, and corrected during construction (Site Photo 8). Specifically, the connections between the smaller-diameter feeder drain lines and the larger-diameter main drain line system were

Site Photo 8. Extensive rework was required in dormitories to install watertight plumbing fittings. (Photo courtesy of ECCI)

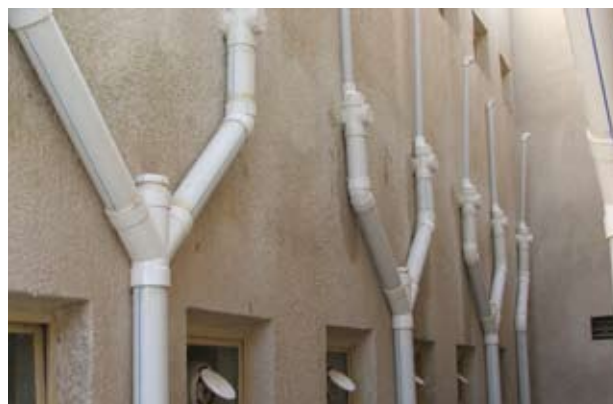
not water-tight because positive connection (glued or threaded) reducers and fittings were not used until the deficiencies were corrected. When corrected, the contractor improved the plumbing design and upgraded the materials (Site Photo 9).

Site Photo 9. Reworked drain lines with upgraded material and improved "Y" design.

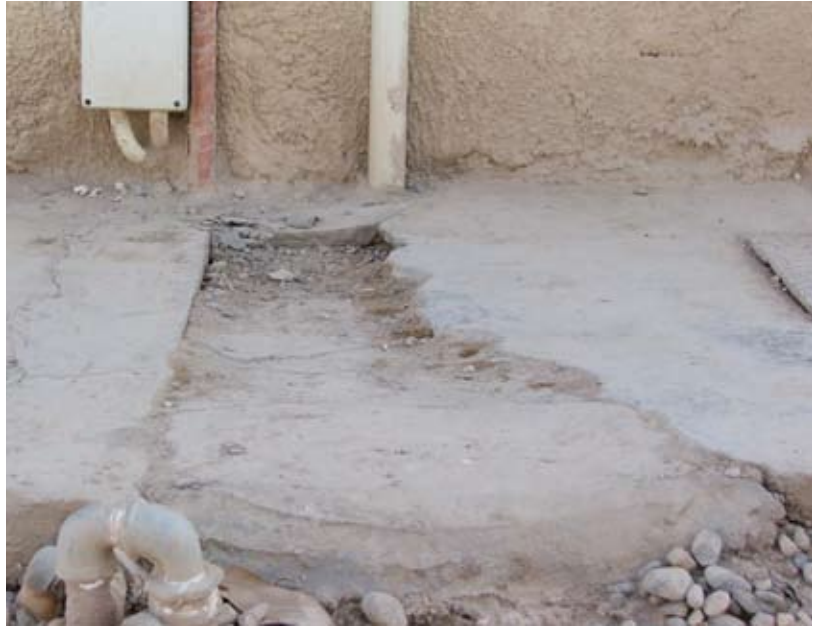
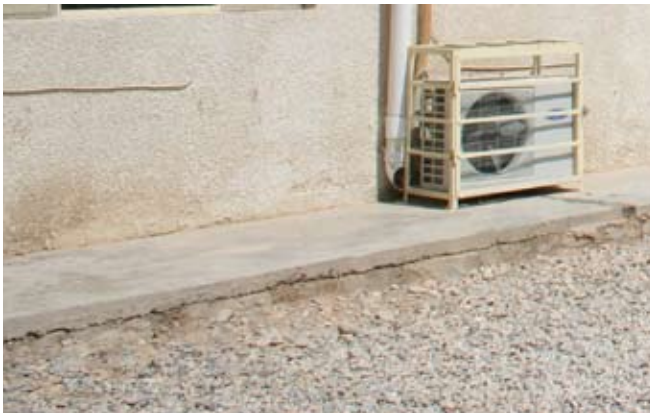
The assessment team observed horizontal fractures that ran almost the entire perimeter

of the newly constructed middle and eastern barracks building foundations (Site Photos 12 and 13). Although not as obvious, similar horizontal fissures were observed on the second floors of the dormitories.

During the assessment, the contractor's Project Manager confirmed that concrete placement was conducted using small batches mixed by hand. Small hand-batch mixing and improper joining techniques could have contributed to the horizontal fractures and other concrete issues observed: the numerous small batches mixed by hand were not consistent. For expediency, each small batch was not subjected to a slump test.

Site Photo 12. Horizontal fracturing along foundation of Middle Barracks.

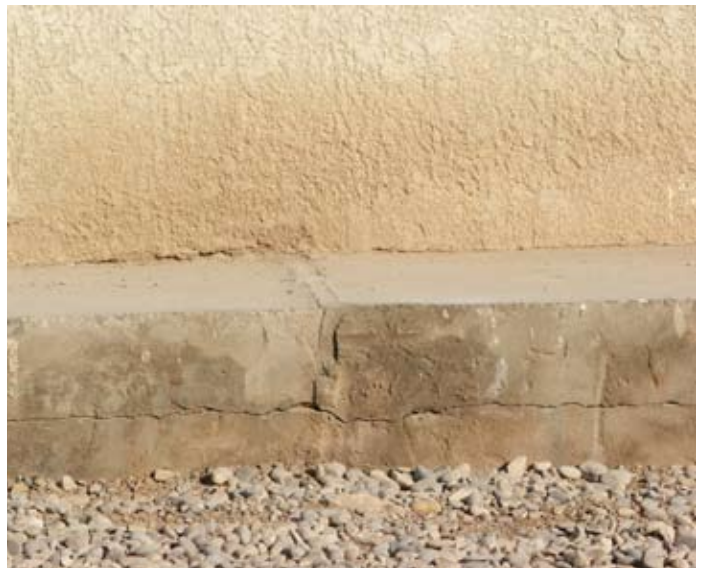
Site Photo 13. Close-up of the horizontal foundation fracture in the East Barracks.

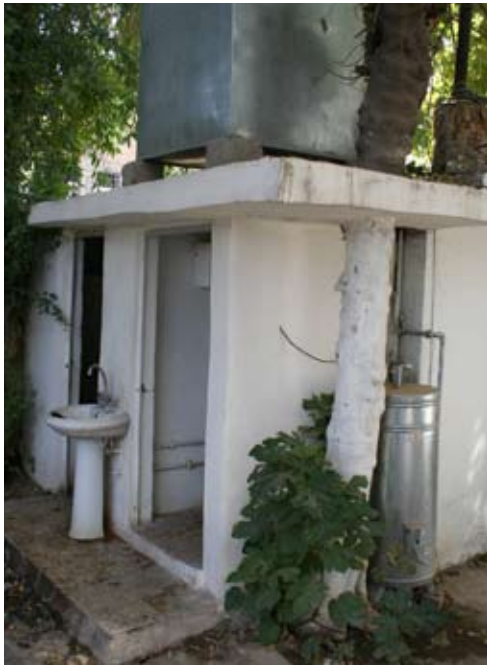
Site Photo 14. Trees were not removed when the new latrine was built.

Rather than removing the second tree, the contractor cast the latrine's concrete roof around the tree (Site Photo 14). The new latrine was not only missing numerous requirements, but the finished construction was substandard.

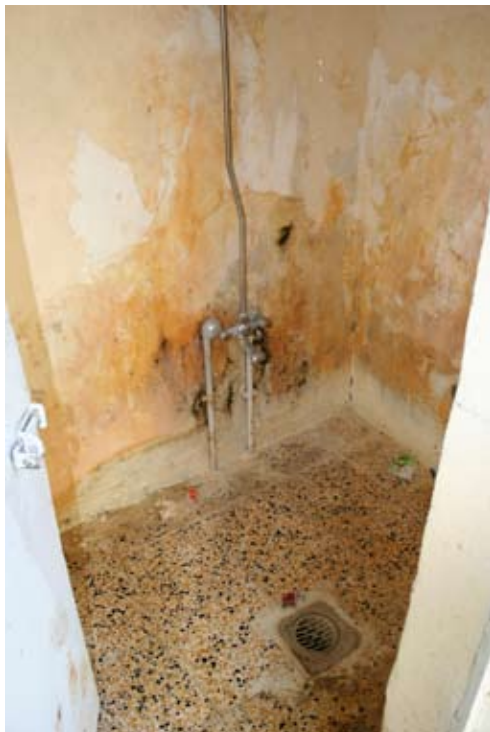
Although the SOW and Statement of Requirements and Specifications (SORS) clearly required latrines/bathrooms and showers to have tiled and grouted walls from floor to ceiling, with new piping, fixtures, and faucets, the contractor's performance was substandard in nearly all the bathrooms observed during SIGIR's on-site visit. Generally, plastered walls and existing tile throughout the facility were merely painted over (Site Photos 15 and 16).

Site Photo 15. Painted plaster shower wall should have been grouted tile, floor to ceiling.

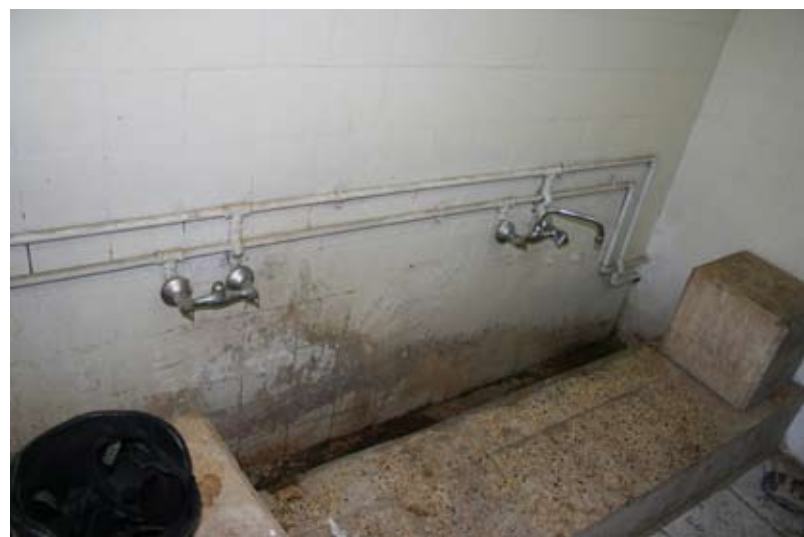
Site Photo 16. Existing wall tile was painted, and existing leaking faucets were not replaced. The left faucet in the photo's center was capped/disabled rather than replaced as required.

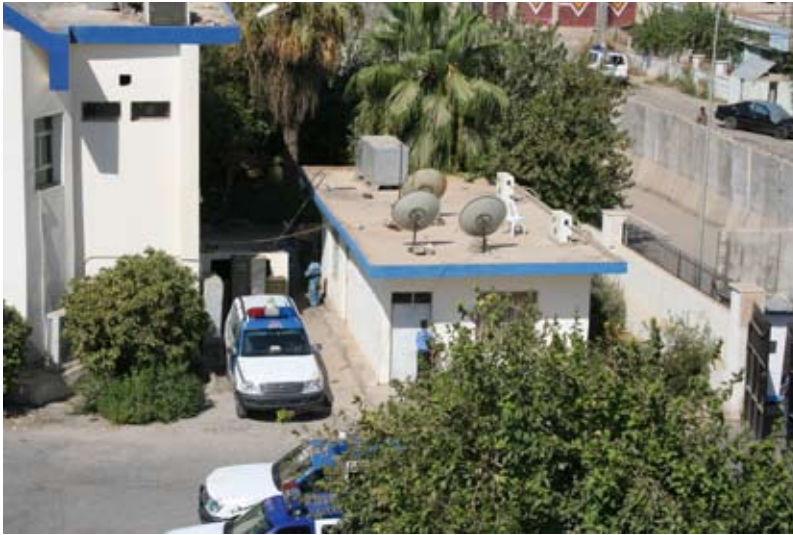
only two of six required split-unit air conditioner systems in the new reception center building (Site Photo 17).

Site Photo 17. Only two (left rear edge of rooftop) of six split-unit air conditioners required were installed in the new reception center.

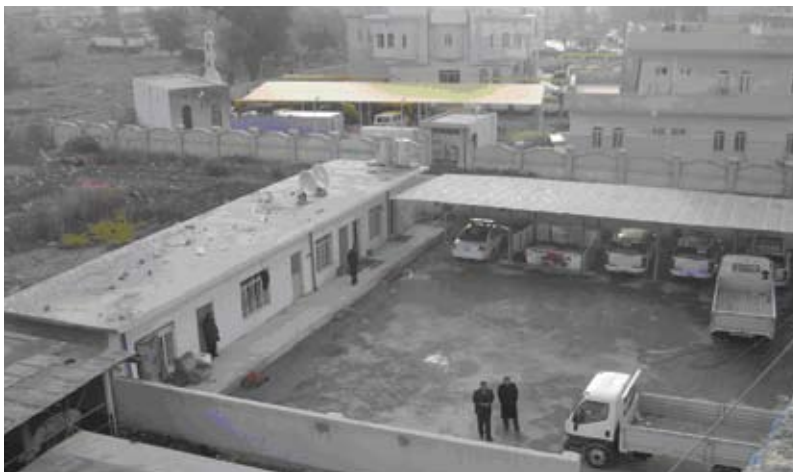
Site Photo 18. Contractor delivered generator (bottom left), but never connected and load tested it.

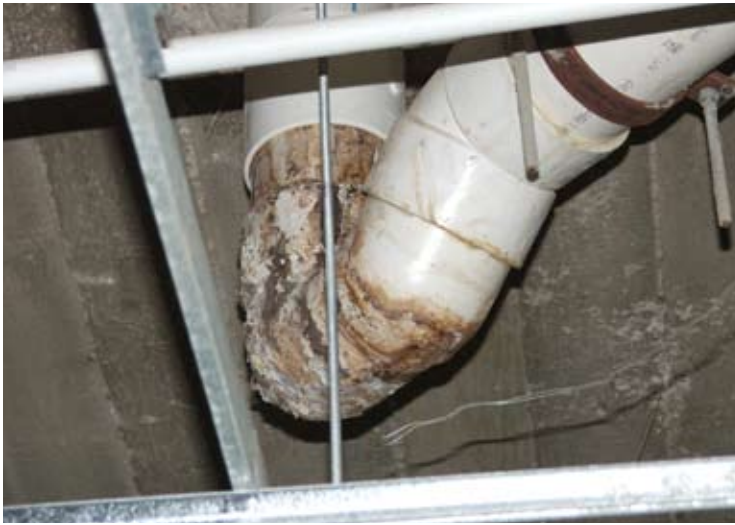
Site Photo 31. View of pipe leaking wastewater.

reporting. Specifically, the improperly fabricated wastewater plumbing (Site Photo 31) in the student barracks could potentially result in reducing load-bearing capacity of the structural slabs and could pose environmental and health hazards to the students, instructors, and workers at the Baghdad Police College.

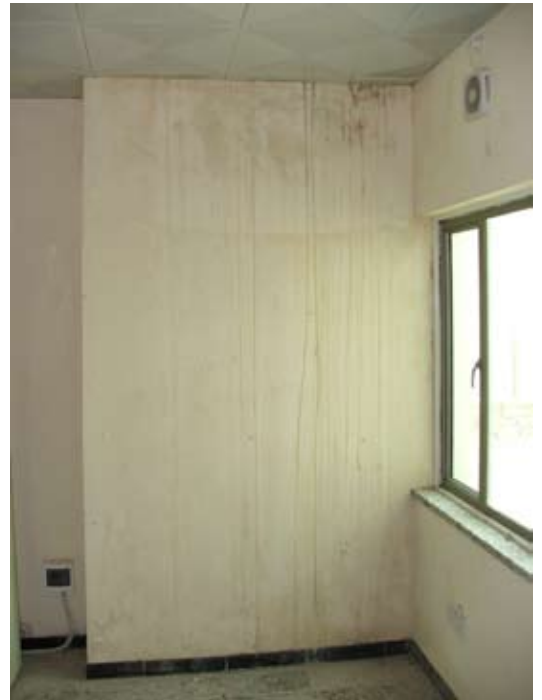
Site Photo 32. Damage to the wall from leaking wastewater.

During the site visit, the team immediately identified water damage and staining on the ceiling and walls of the ground floor (Site Photo 32).

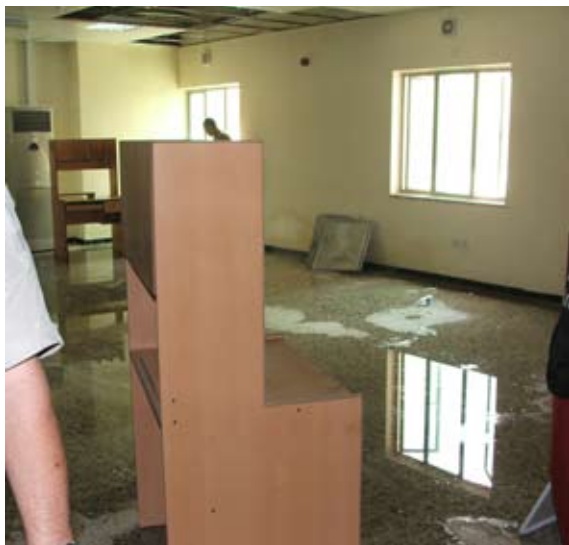
Site Photo 33. Water damage from leaking ceiling.

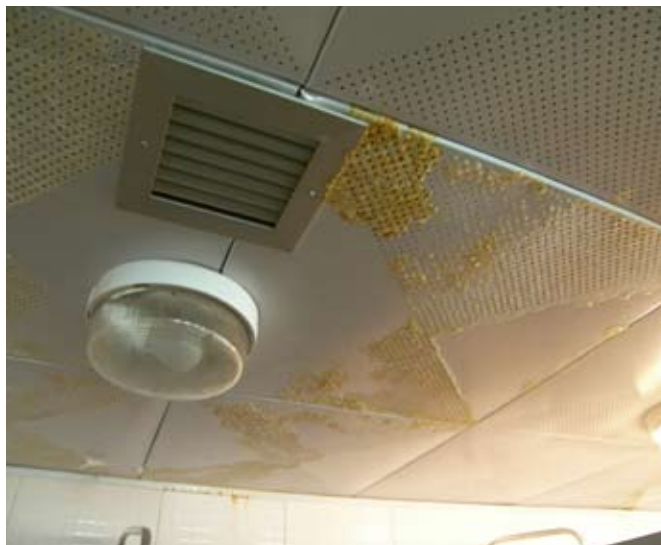
Site Photo 34. Crystallized urine on ceiling tile.

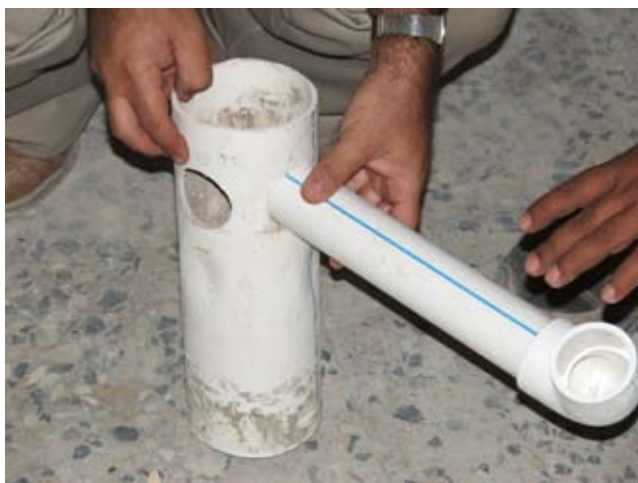
Site Photo 35. Typical contractor-built wastewater pipe connection method.

the floor surface and/or properly affixed to adjacent fittings with the proper adhesive or sealant, which causes water to drain outside rather than inside the drain collectors.
